# Case Study: TripleHard Mining

- Comparison with hexavalent chromium ( $\text{Cr}^{6+}$ ) and Savroc's trivalent chromium ( $\text{Cr}^{3+}$ ) coating TripleHard®
- $\text{Cr}^{6+}$ : Base material AISI 329 and 20MnV6
- TripleHard®: Base material 20MnV6 normal steel
- Very demanding environment in Australian mines
- Salt and high temperature → Corrosion

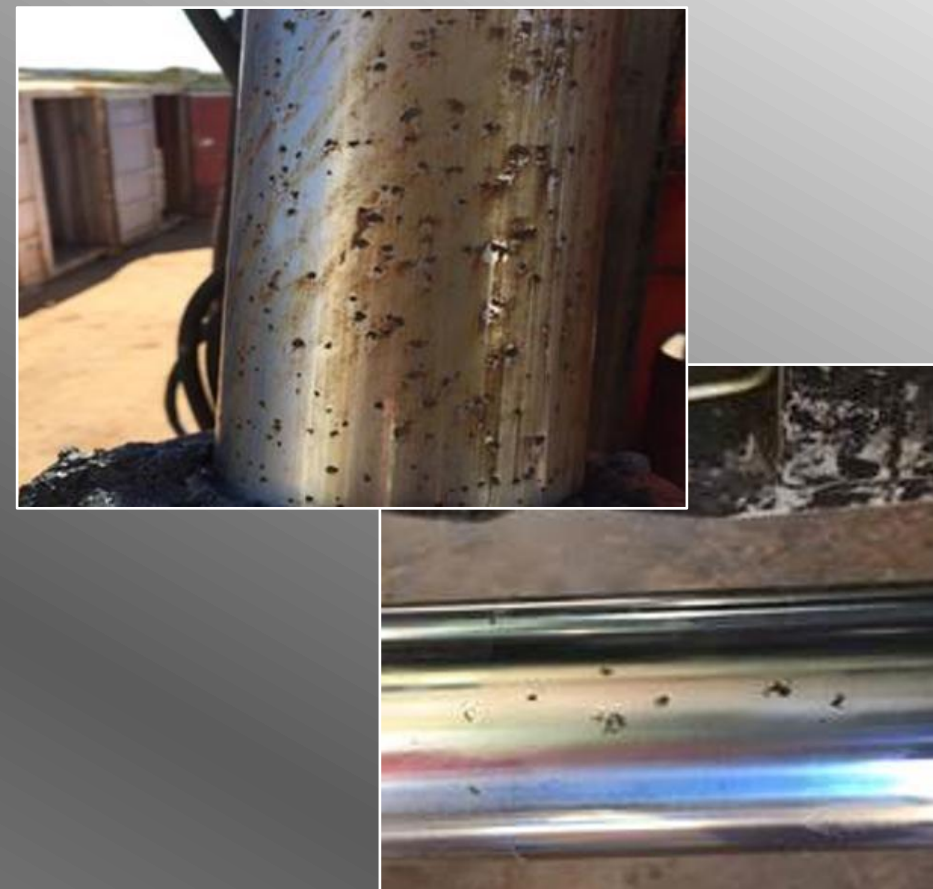
20MnV6 + Cr<sup>6+</sup>:

- After 2 months
- Base material: 20MnV6 – normal steel
- Poor corrosion resistance – easy to see a lot of rust

Consequence: cylinder replacement is necessary

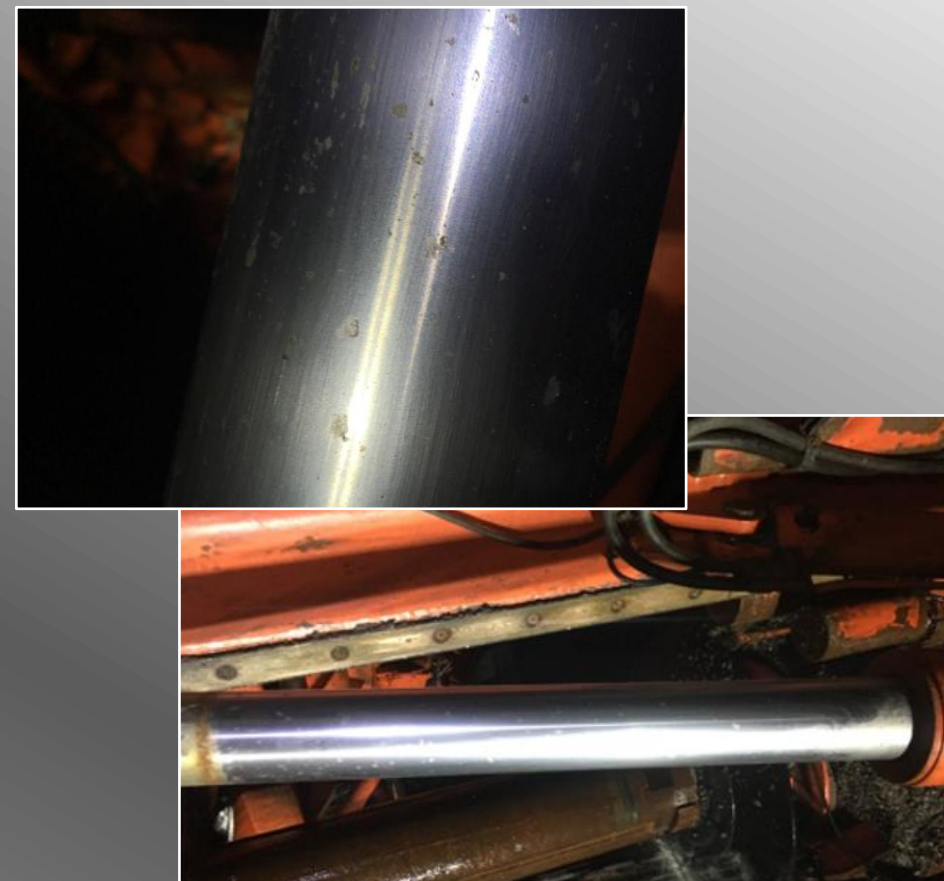
AISI 329 + Cr<sup>6+</sup>:

- After 4 months
- Base material: AISI 329 – stainless-steel
- Sub-optimal corrosion resistance – easy to see a rust

Even stainless-steel rod is rusty

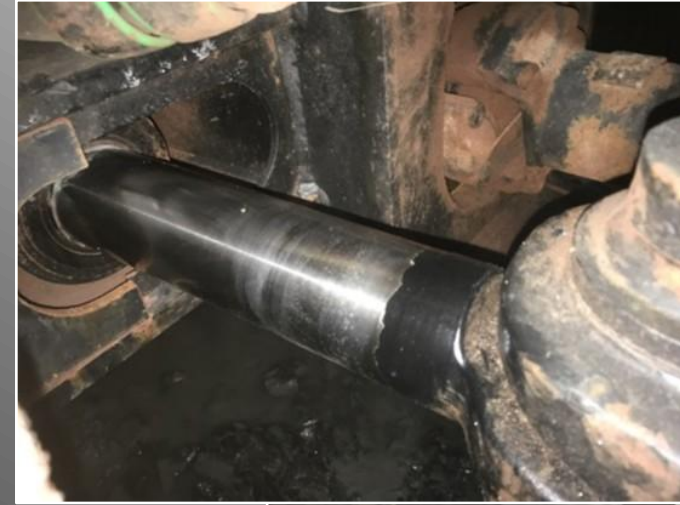
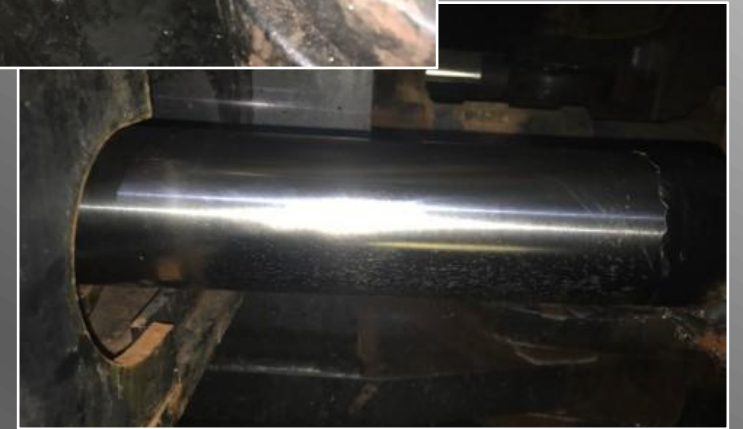
## 20MnV6 + TripleHard:

- After 34 months
- Base material: 20MnV6 normal steel
- Excellent corrosion resistance – no rust

Normal steel coated with TripleHard performs significantly better than stainless-steel coated with  $\text{Cr}^{6+}$

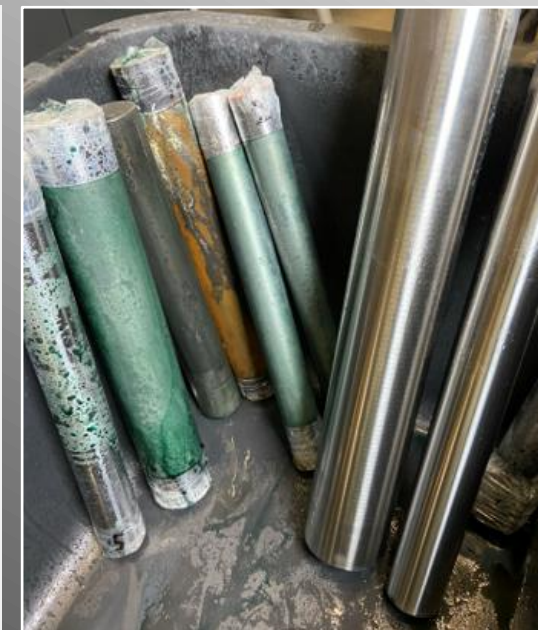
Commercial Cr<sup>6+</sup> coatings vs. TripleHard® after 5 days of mine water spraying
